**CALSPAN ON-SITE CHILD SAFETY SEAT CRASH INVESTIGATION**

**CALSPAN CASE NO. 94-22**

**VEHICLE #1 - 1993 OLDSMOBILE CUTLASS SUPREME  
VEHICLE #2 - 1994 FREIGHTLINER TRACTOR/SEMI-TRAILER**

**LOCATION - STATE OF NEW YORK**

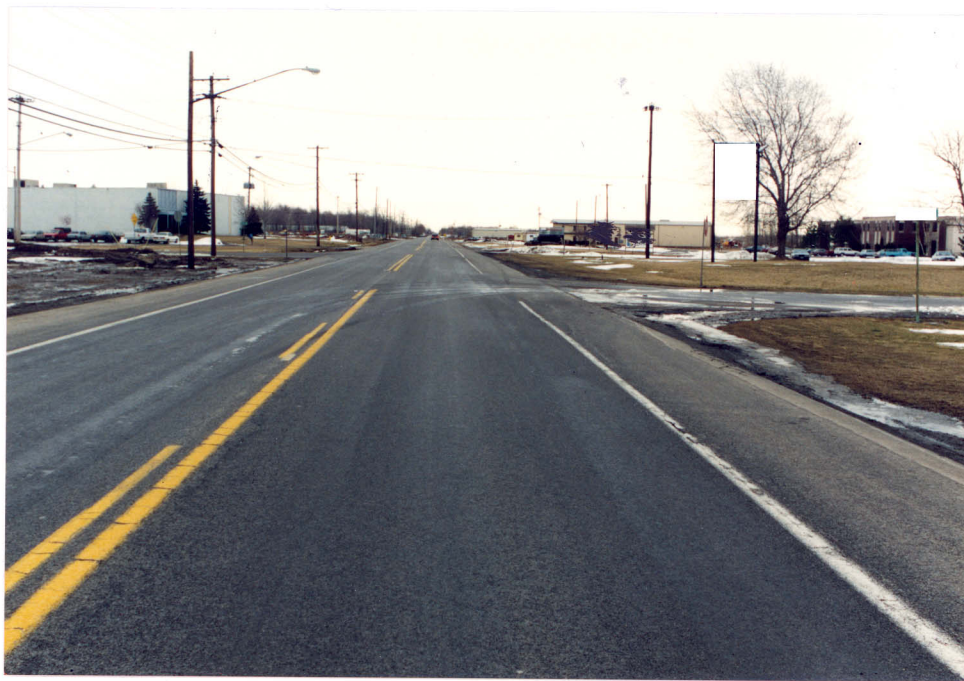
1. Trajectory of Vehicle #1 (1993 Oldsmobile Cutlass Supreme) traveling eastbound - 122 meters (400') prior to the point of impact (POI).

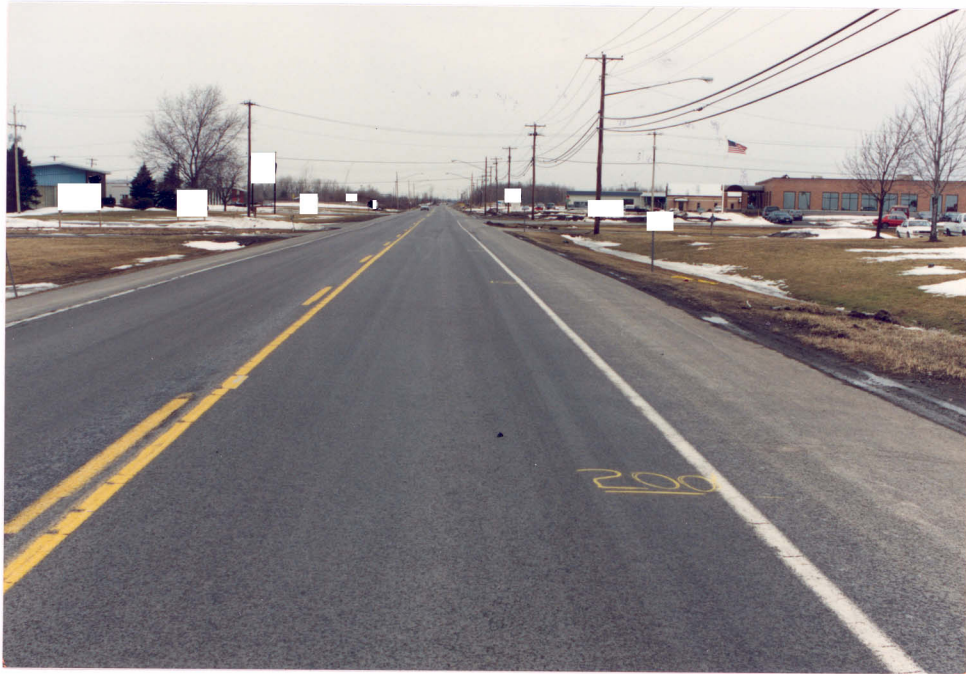
12. View looking eastward beyond Vehicle #1's FRP.

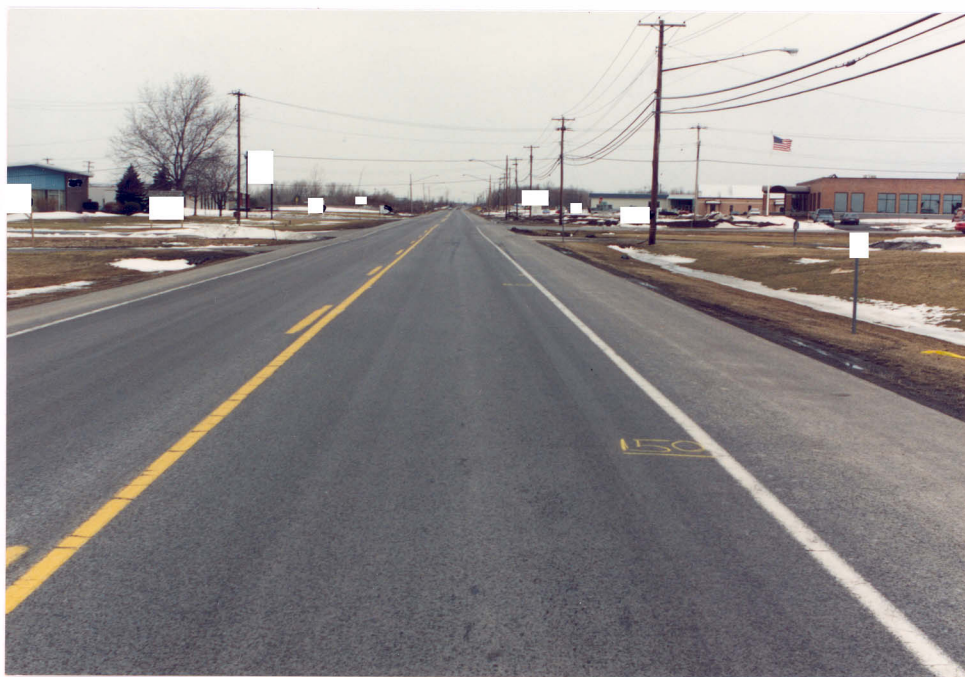
13. Trajectory of Vehicle #2 - 31 meters (200') prior to the POI.

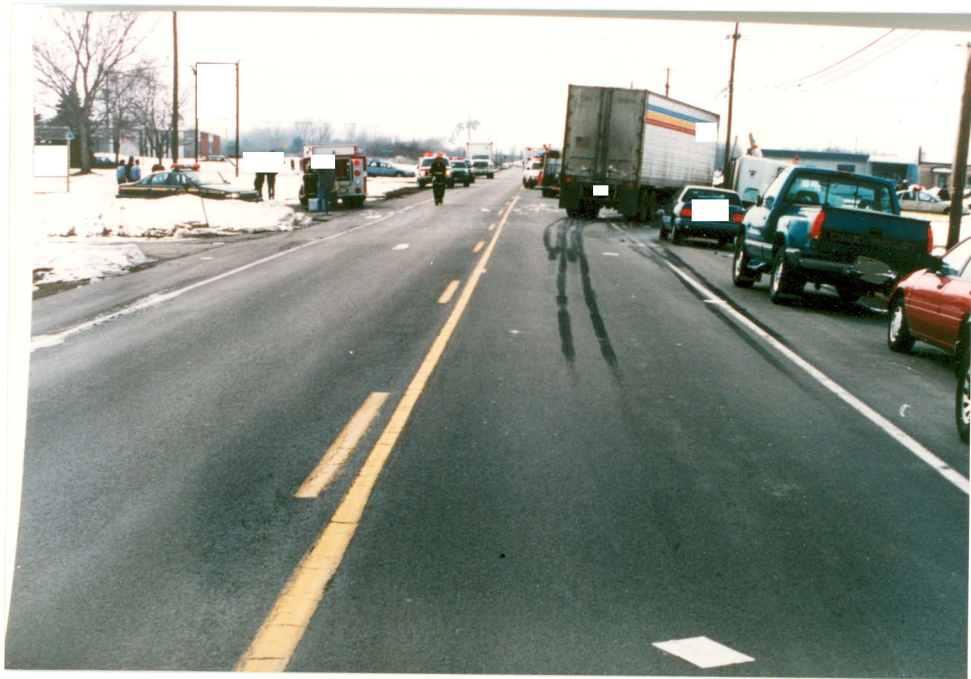
30. Reverse view of Vehicle #2's trajectory looking from beyond the FRP positions of Vehicle #1 and Vehicle #2.

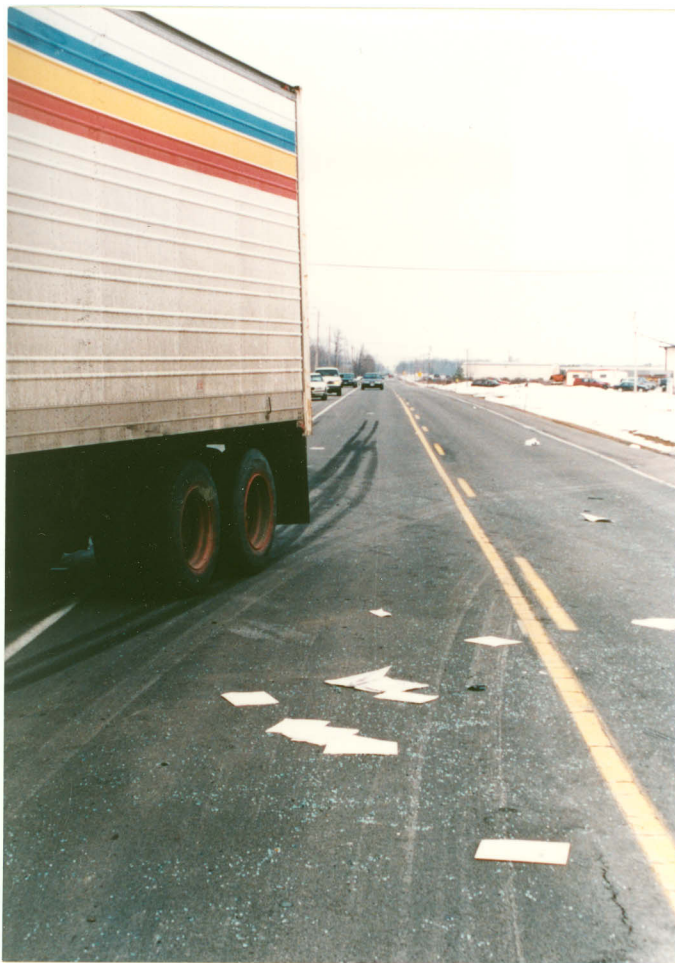
35. On-scene view of Vehicle #1's and Vehicle #2's FRP looking in a southwesterly direction.

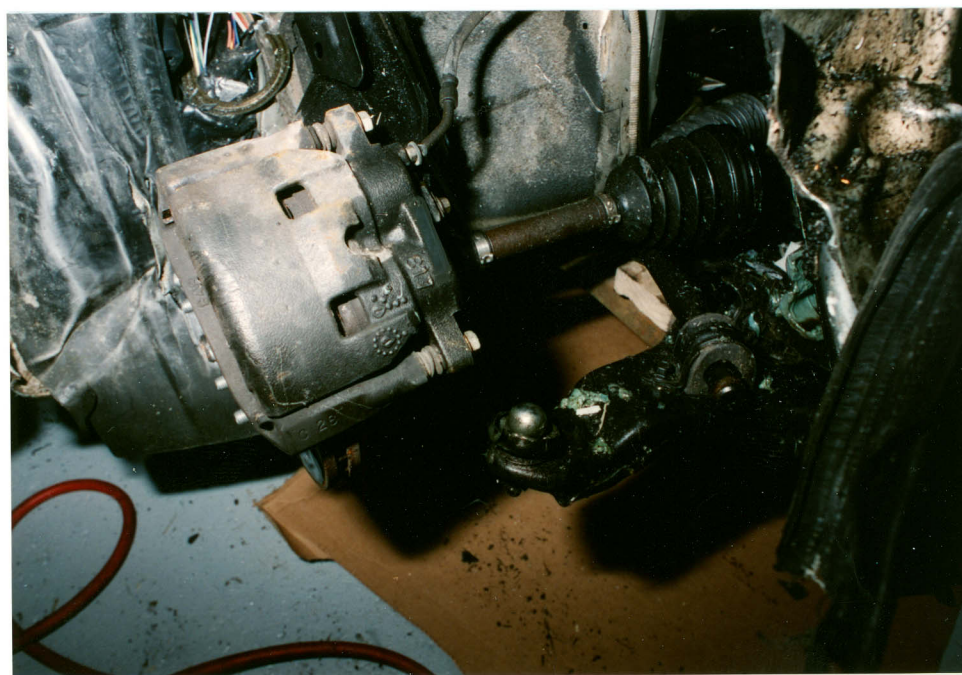
53. View of the right front fender, brake caliper, and door surface.

Damaged components included: the front bumper; grille; hood/fender assembly; left front tire; radiator; engine components; frame; front axle quick release air valve; and right front air brake cam shaft chamber. The left front tire was punctured along the outboard tread rib from the cylindrical right front door beam of Vehicle #1 (refer to photographs #98, #53 on pages A-49, A-27).

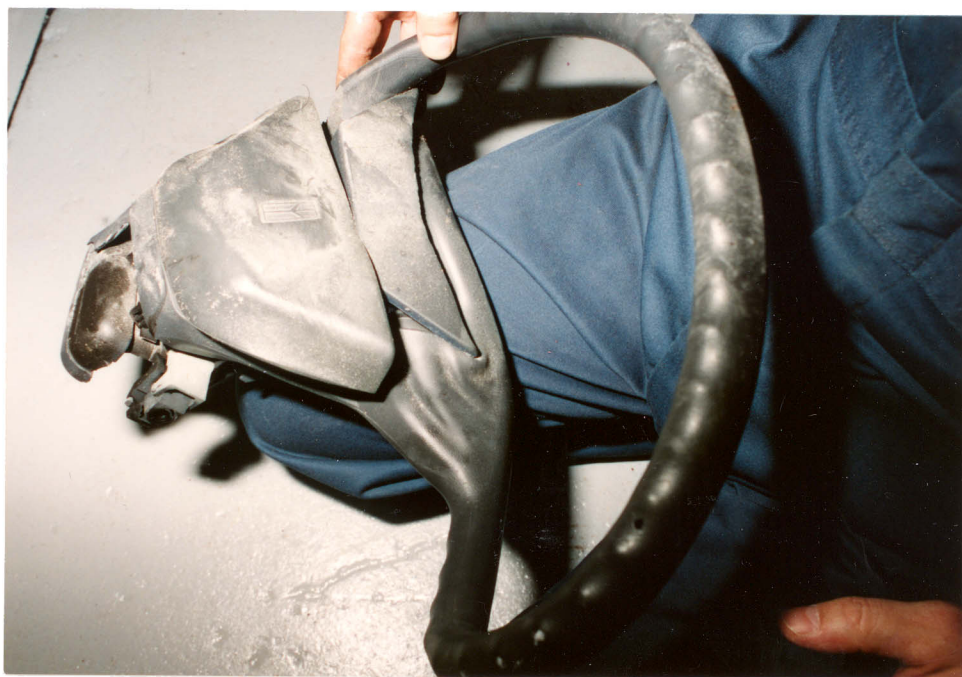
61. Close-up view of the steering column. Note its position with the leading edge of the driver's seat cushion.

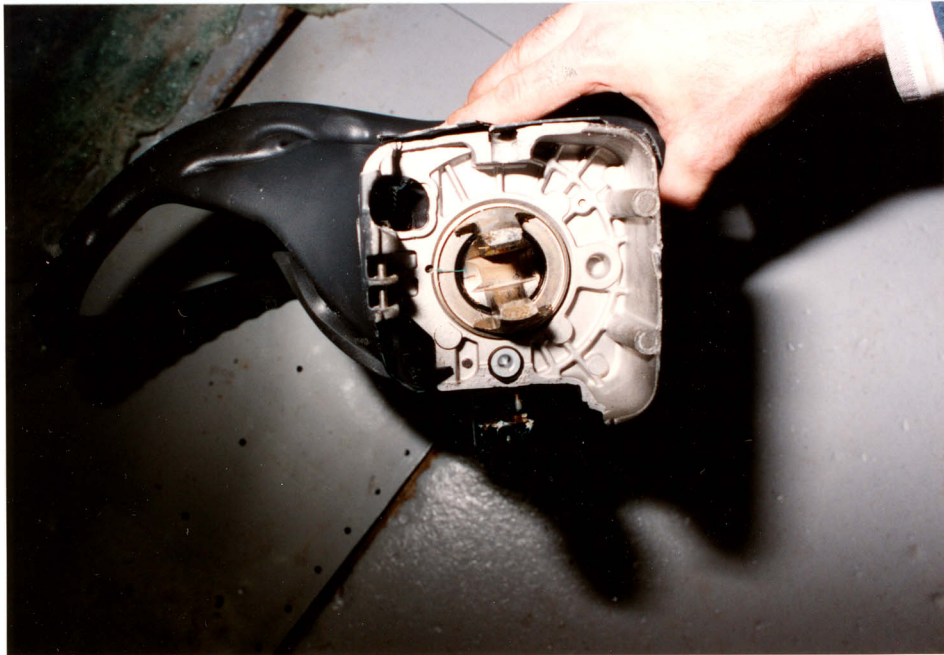
63. Another view of the steering wheel.

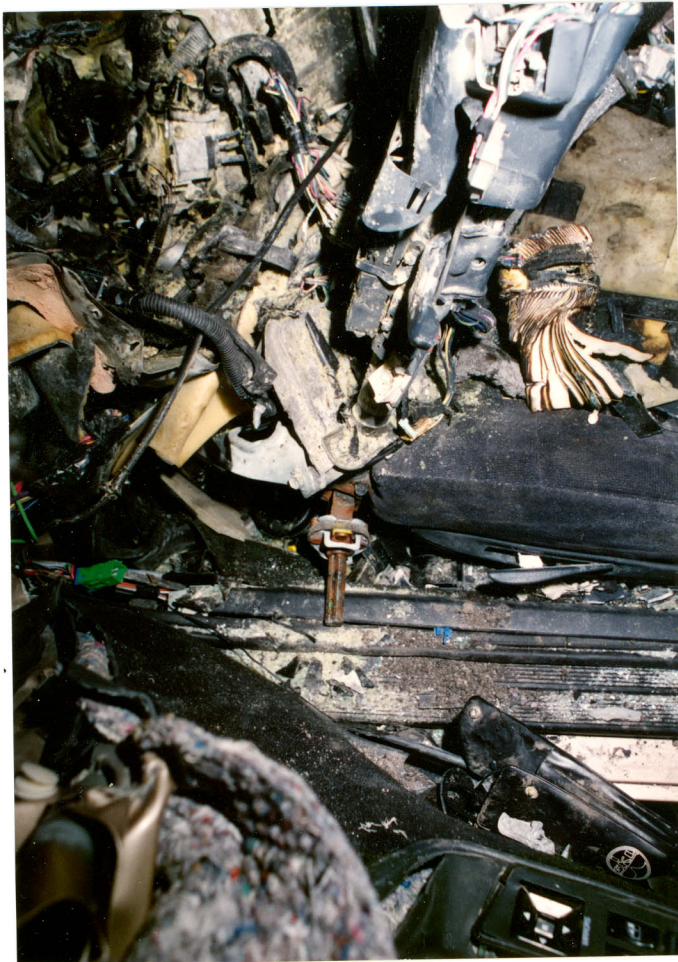
65. View showing the close proximity of the instrument panel and steering column to the left front seat cushion.

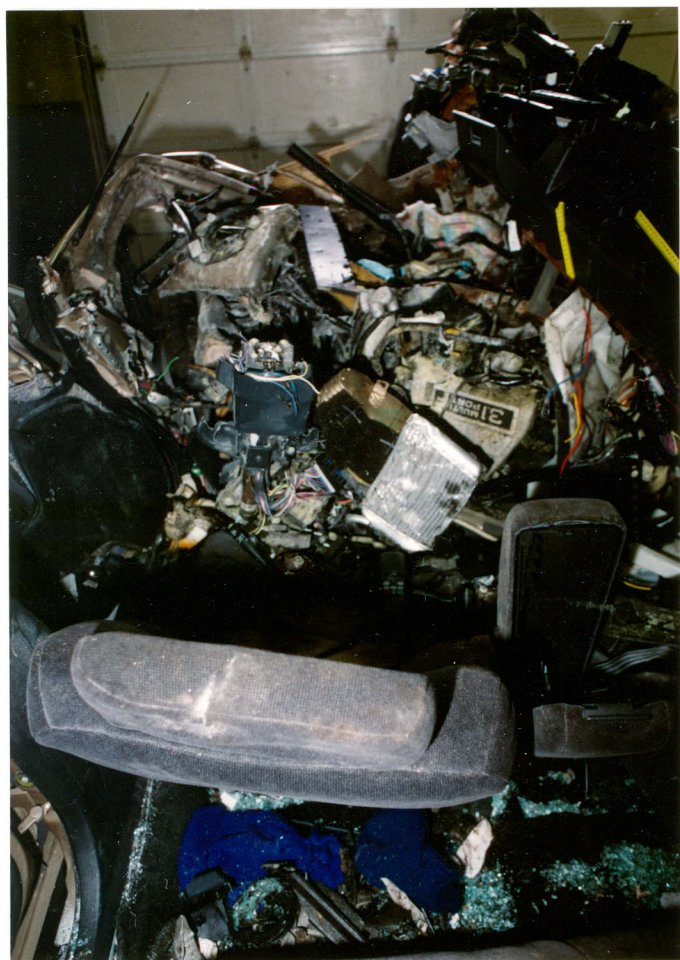
66. Overhead view of the driver's seat back rest and instrument panel. The engine intake manifold is visible in the center of the photograph and is identified by the "3.1 Multi Port" lettering.

Damage to the interior was extensive which was associated with component intrusions and occupant contacts. The engine was displaced rearward and intruded into the occupant passenger compartment (refer to photographs #66, #68 on pages A-33, A-34). The windshield with the exception of a small area at the windshield header was totally separated from the vehicle. Hair (appeared to be eyebrow hair) and tissue transfers were noted forward of the driver's position. The hair was located 34.3 cm (13.5") left of the vehicle centerline and extended 27.9 cm to 38.1 cm (11.0"-15.0") below the windshield header. The tissue transfer was located 25.4 cm to 37.5 cm (10.0"-14.75") left of the centerline (refer to photographs #55, #56 on page A-28).

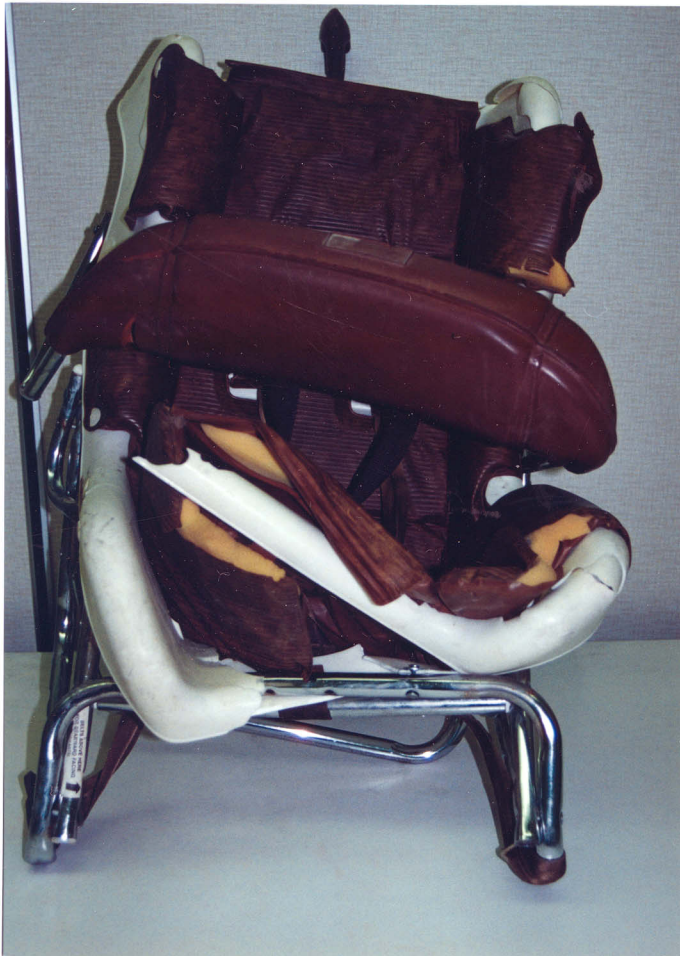
83. Lateral view of the rear seat looking from the right side of the vehicle.

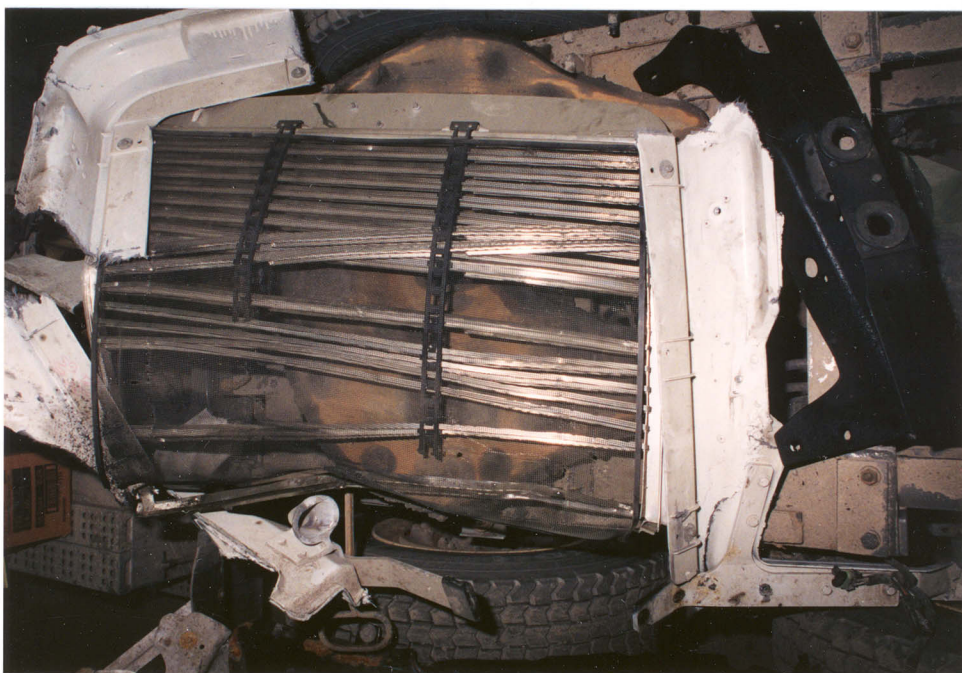
92. Frontal view of Vehicle #2 (1994 Freightliner truck-tractor) as seen during repair activities.

The frontal plane of Vehicle #2 was struck by the frontal plane of Vehicle #1. The vehicle was in the process of being repaired at the time of inspection. Direct contact to the front bumper measured 129.3 cm (50.9"). Crush measurements were not be obtained due to the bumper removal (refer to photographs #92, #94 on pages A-46, A-47). The crush pattern was concentrated near the center of the bumper and was consistent with the contact pattern with Vehicle #1.

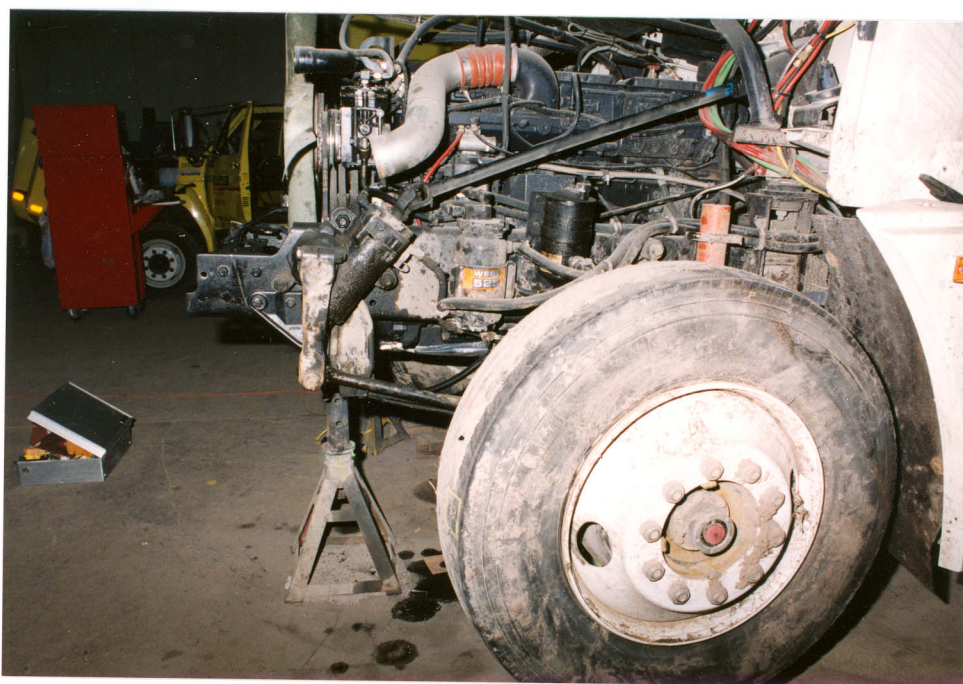
98. Close-up view of the left front tire highlighting a gouge in the outer edge of the tread resulting from contact with Vehicle #1's right front door reinforcement beam (refer to photograph # 53 on page A-27).

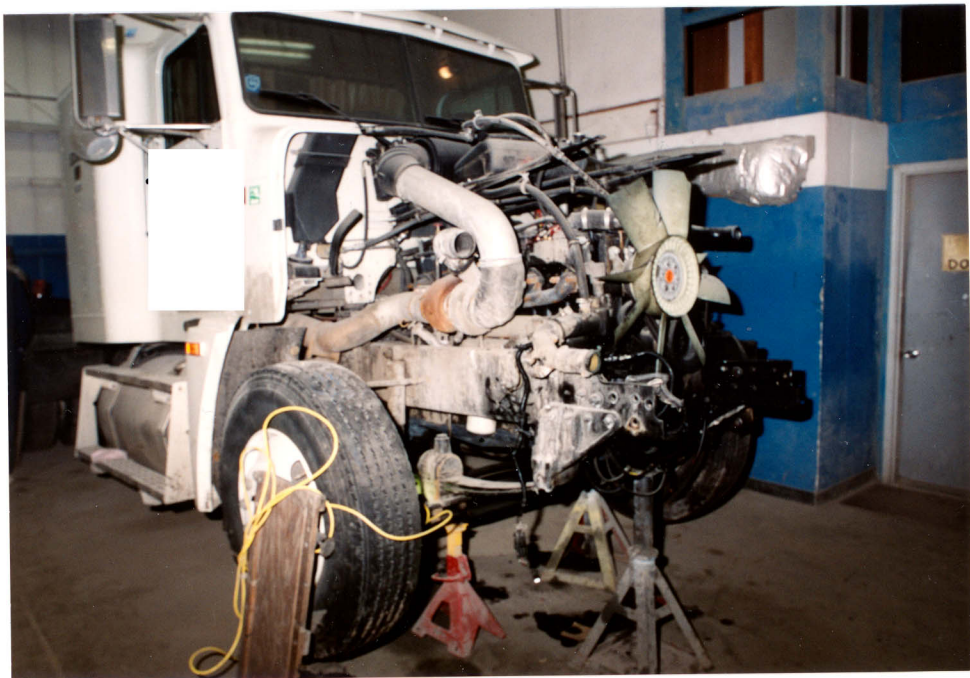
102. Lateral view of the right front side plane.
